UTAH STATE CAPITOL ARCHITECTURE: INTERIOR PRESERVATION I SURVEY REPORT

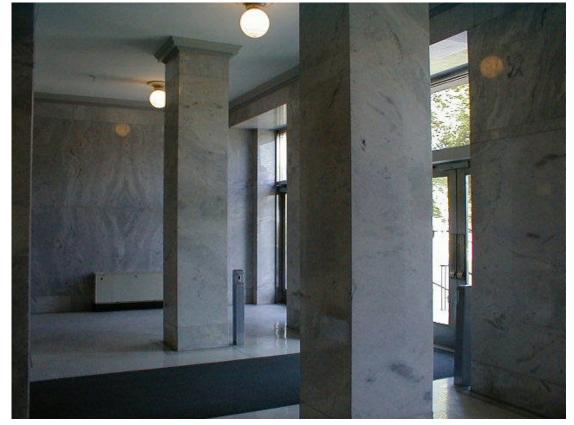
100ve East Vestibule 1st Floor

Condition Fair

Notes Mouldings are in fair condition -

a few dirt/burn spots? Should be

checked.

Condition Poor

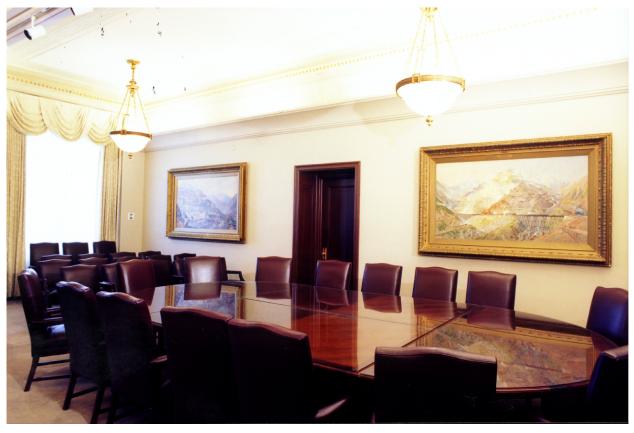
200

Notes faux bois 6" grained, not

original? Very simple

Notes not original

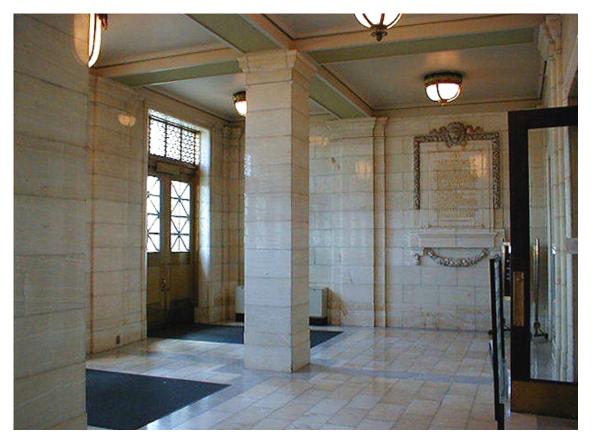
200vs

Condition Fair

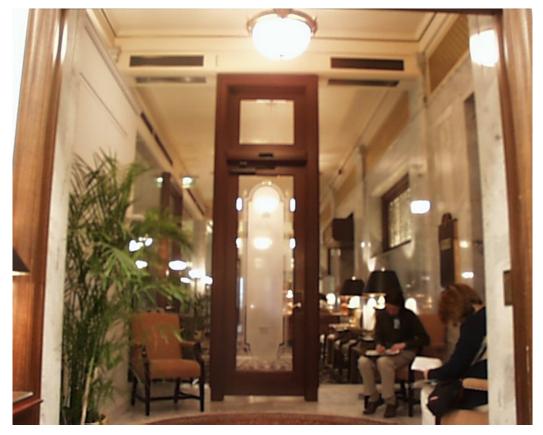
201

Notes similar to 208K includes 209 - vestibule to offices - south of lobby.

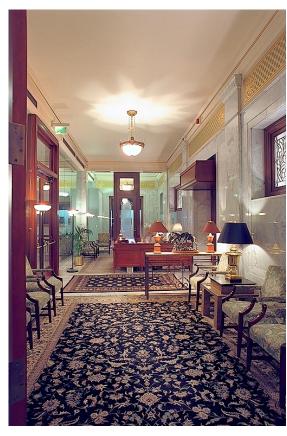
Notes when the glass wall was added in 1993, a private foyer was created, purportedly saving the Board Room from becoming a passage and even the Gold Room from becoming the new board room.

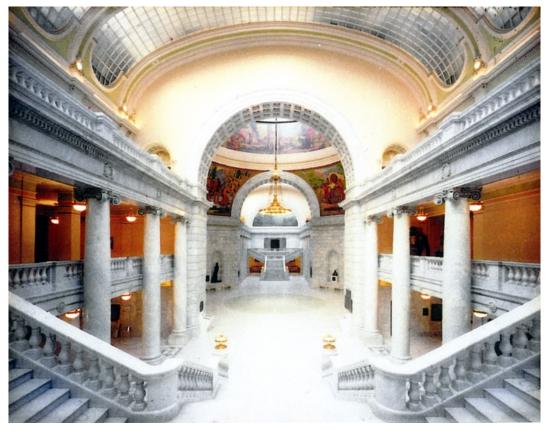
Atruim, Rotunda, main corridors

Notes Includes the 3rd and 4th floor corridors, 380 and 470 respectively.

> the Rotunda area. They have been given a faux finish to resemble the marble. Replacement should be

Good condition overall - could Notes

use some repair work in various places, marble is wearing. Very Usefull and attractive to the public. The underside of the landing - is being used for sculptural and aesthetic display.

They were rebuilt in 1995. Further notes on these can be found in the exterior survey

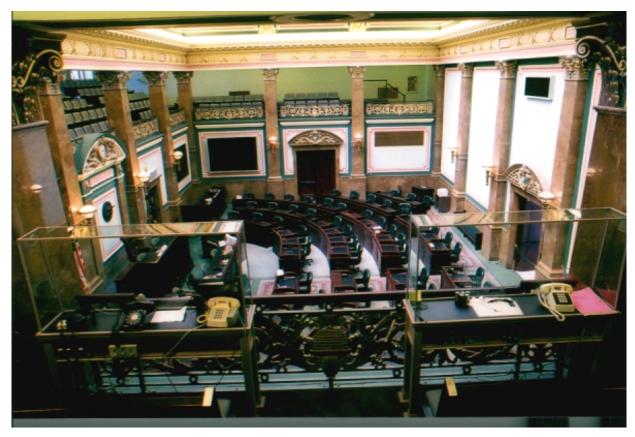
House of Representatives Chamber Preservation Level I

Notes see Section X. Finishes for historic palette. This chamber has varied more than other in its color scheme.

(original?) replaced glass doesn't match pattern, color

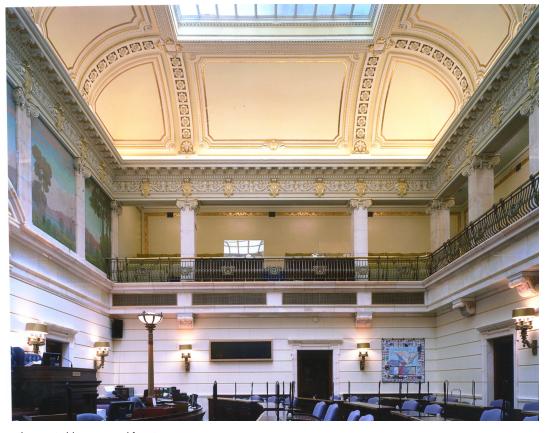
Original Use Senate Chamber

Notes has 2 coat/listening rooms on the west side now used for storage

Was replaced in the 1950s after Notes

failing. Top railing is not historic.
